**Flood Control Project Maintenance
Levee Inspections**

Maintenance Issue Types Only, Levee Inspection Report By Mile - Fall 2018

Reclamation District No. 0349 Sutter Island

Waterway	Bank	Unit Miles	Inspection Start/End	Inspector
Unit No. 01 Sacramento River	Right	1.59	11/08/2018 11/08/2018	David Julian

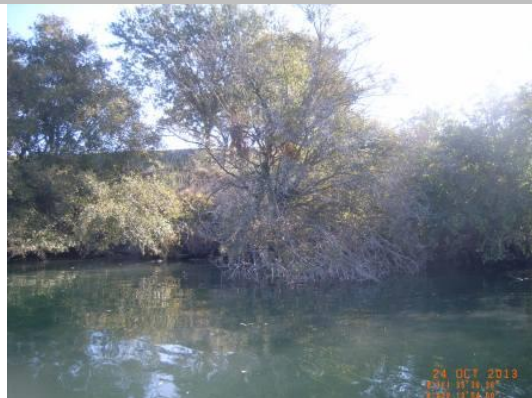
Photo 1 of 1 : FA_2018_RD0349_206_115_20181119_00096.jpg

Comment Code					
Inspector Comment					
2017 Site ID: STR 26.5 L					
Status: Eroding					
2017 Field Notes: There appears soil under geotech fabric that appears to be failing but hard to tell.					
Site History: 2002 - Original rock over geotextile is sliding off and the end is coming unraveled. 2003 - Some minor new erosion on the downstream end. 2004 - Site has gotten worse. Underlined geofabric is exposed. 2005 - Still looks bad with exposed geotextile fabric. 2006 - Still have some new unraveling and exposed fabric. Site lengthened upstream. 2009 - Minimal new erosion. 2010 - geotextile fabric placed since last year, possible flood fight. 2012 - Exposed geotech style fabric, assume rock on top slid off. 2015 - Erosion pockets covered with plastic. 2018 DWR Inspector: This was rated as A/W due to the inability to verify the rating at the time of inspection. This site will be verified during the next inspection.
